## LIMITED SURVEY REPORT OF THE SS CATALA

*Trim Starboard View of SS Catala*

Washington State Department of Ecology

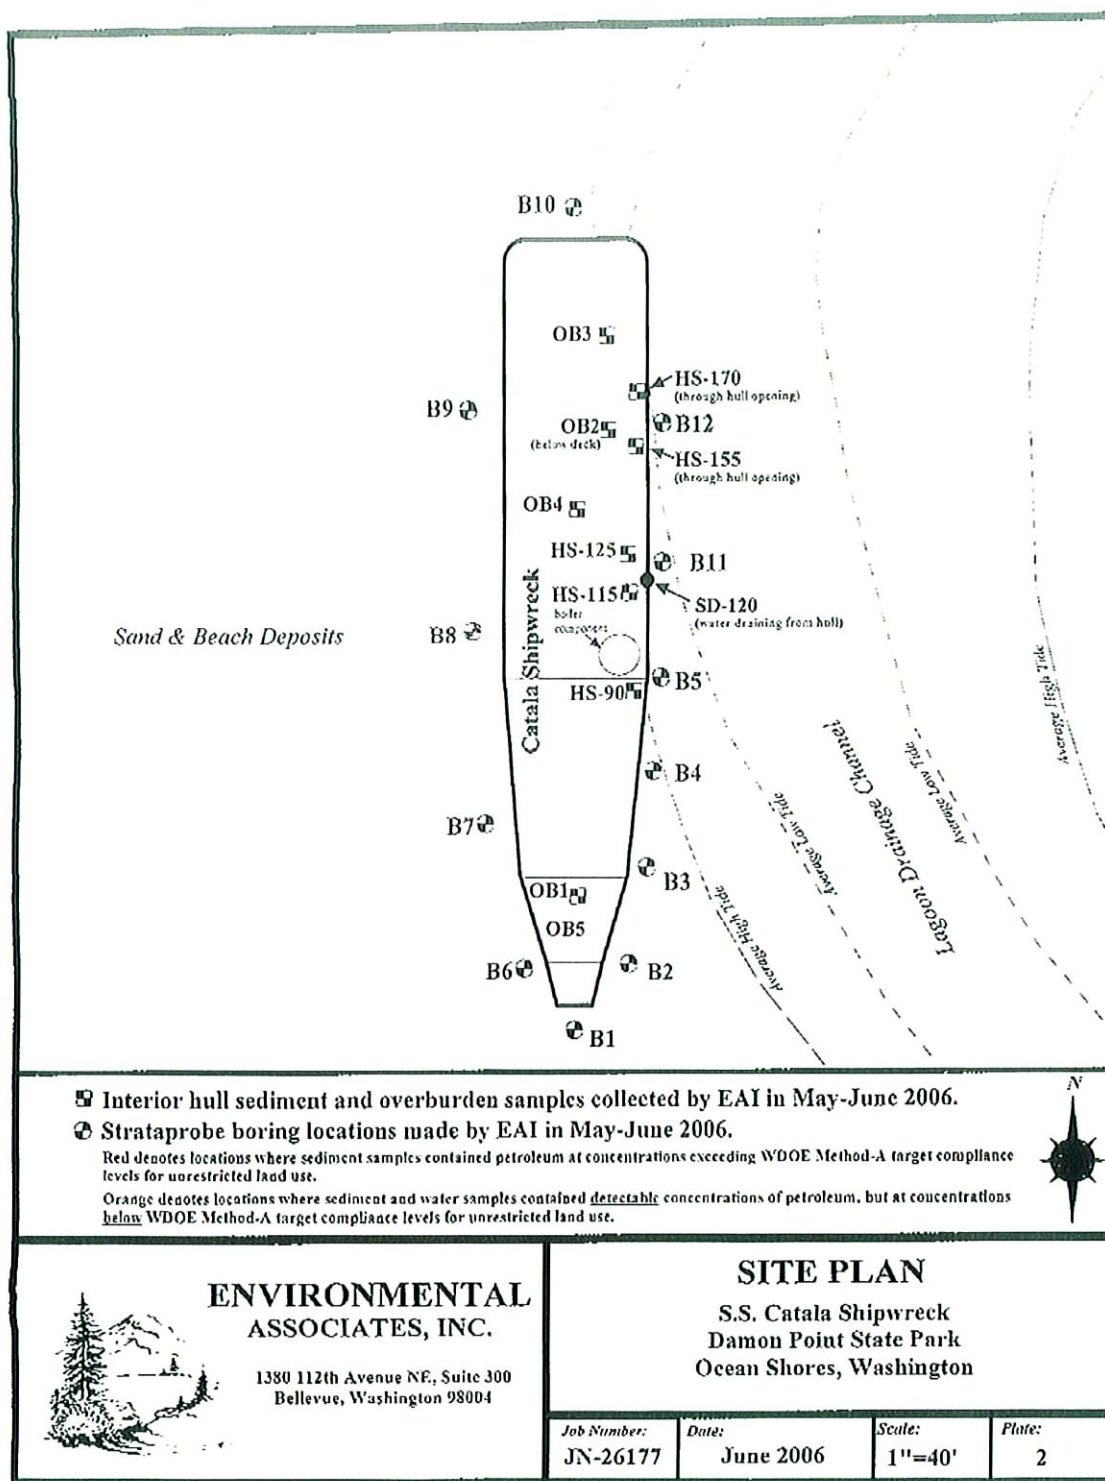
Of the twelve perimeter boring core samples that were taken, most did not appear contaminated, nor exhibit residual tar like texture or pronounced bunker oil odor. Eleven of the boring locations all resulted in < 50 ppm. However, one sample (B8 @ 11-12') resulted in 260 ppm; well below the target compliance level for Washington State Department of Ecology MTCA Method A (2,000 ppm). It is possible that this location at one time was exposed to uncontrolled release from the vessel. An interesting note is that the location is on the starboard side of the vessel amidships.

Of the twelve perimeter groundwater samples taken, eleven of the samples resulted in < 250 ppb. However, one sample (B8) resulted in 420 ppb; again, below the target compliance level (500 ppb). It is the corresponding groundwater sample from the above boring location on the starboard side of the vessel.

The five sediment samples taken from within the vessel's hull resulted in mixed results. The sediment sample taken directly above No. 1 Fuel Oil Tank (HS-90) resulted in 95,000 ppm, above target compliance levels. Correspondingly, two sediment samples taken directly above No. 2 Fuel Oil Tank (HS-115 and HS-125) resulted in elevated contamination ranges (6,100 ppm and 18,000 ppm, respectively), but lower than over No. 1 Fuel Oil Tank. However, two sediment samples taken within the cut-out portion of the vessel's port side further aft both resulted in < 50 ppm.

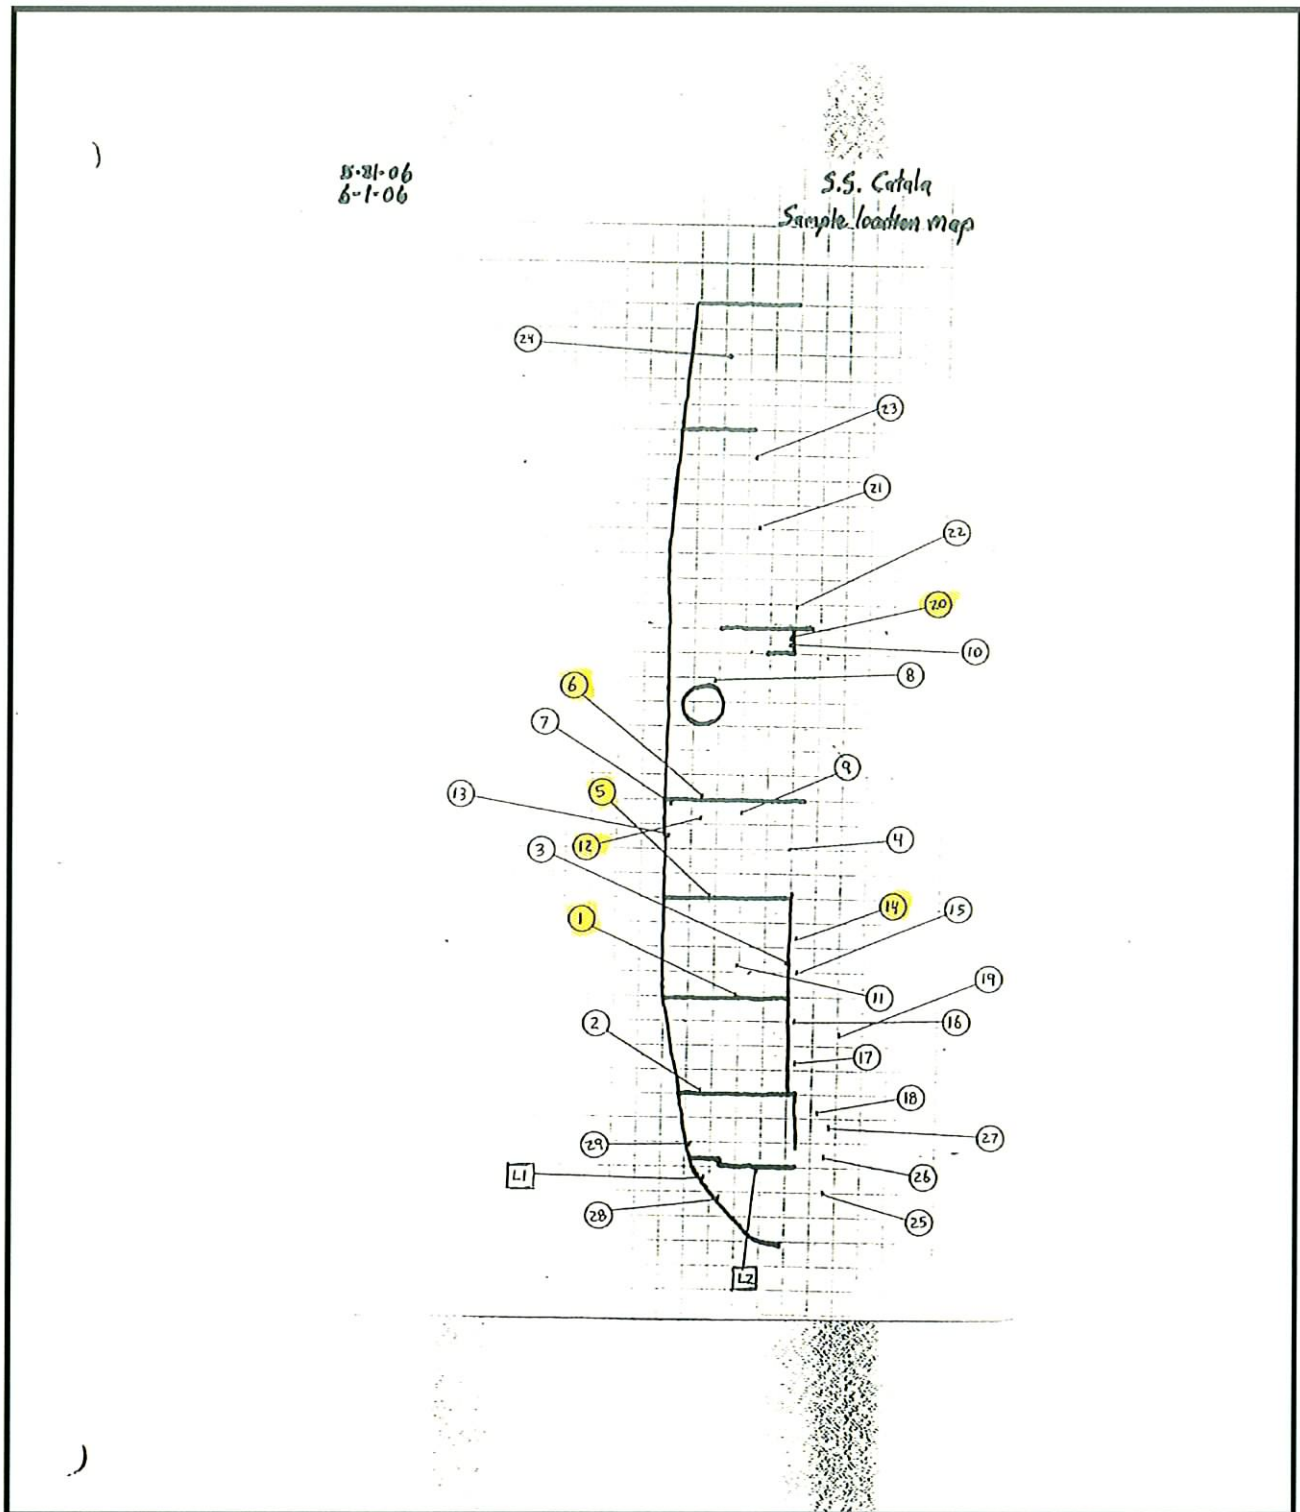
The highest concentrations of asbestos containing material (ACM) were located on the insulated cement board on the bulkheads that were exposed. The various layers of the material contained 25% chrysotile to 45% amosite. Only one sample (JK-1) was submitted for analysis, but two other samples (JK-5 and JK-6) of the same material were collected at other bulkheads, which leads to the assumption that assorted bulkheads exposed and ones currently under sediment within the hull are likely to contained significant ACM.

Various tiling and sheeting on vessel structure floor and bulkheads exhibited ACM with 2% chrysotile, specifically JK-12 and JK-20.

A tar like coating exhibited 2% chrysotile at JK-14.

At various locations where a cement/concrete material was found (JK-7, JK-8, and JK-9), laboratory results found less than 1% anthophyllite used as a binder/filler material.
